## Summary of 2014 Surveys in the Beebe River Watershed

### Stream electrofishing at 19 locations

### Road/Stream Crossing Assessments

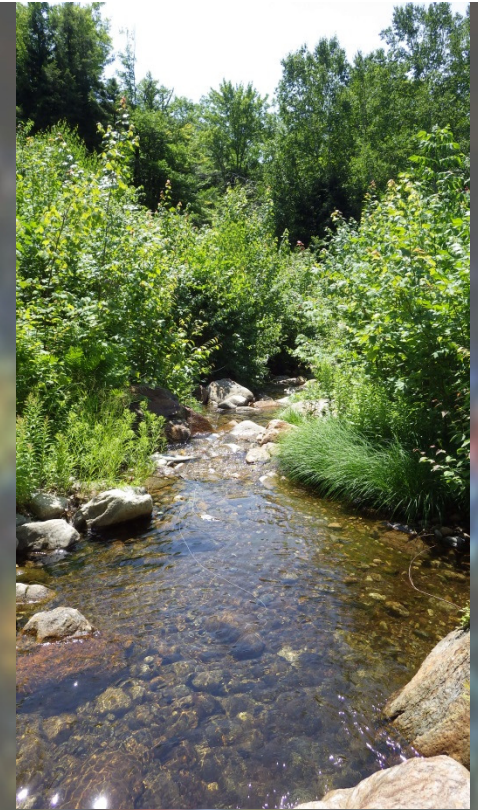
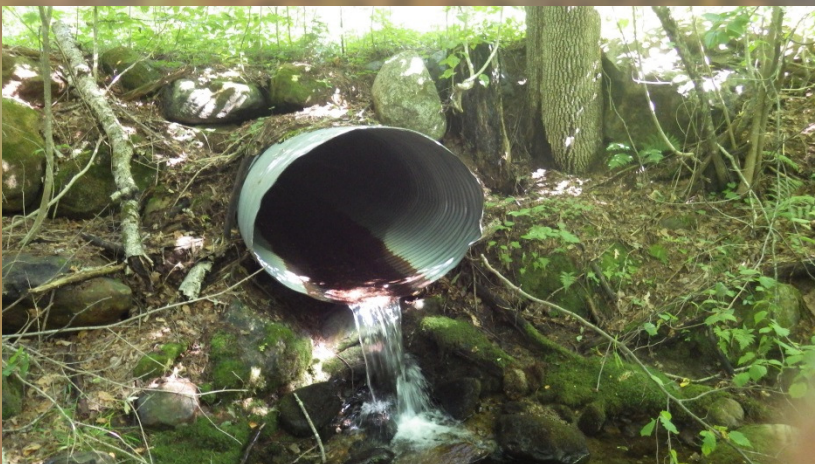
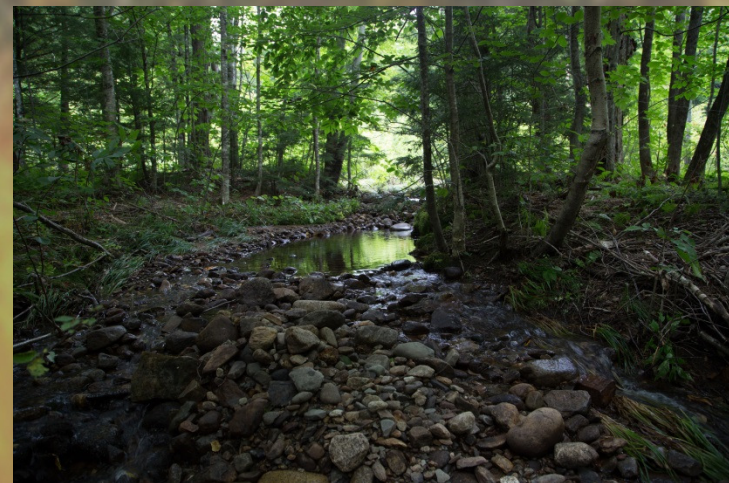
### Loss of canopy in tributaries under power lines

- Increase in water temperatures
- Lack of habitat variety/cover

### Undersized Stream Crossings

- When perched, crossings preventing brook trout from accessing cooler habitats/spawning areas
- When undersized, aggradation and erosion rates may be amplified
  - Lack of spawning gravel below crossings can reduce recruitment success- excessive scouring
  - Accumulation of sediments (aggradation) upstream of crossings can impair passage and compromise roads

- Crossing Replacements (prioritize, funding)
- Wood Additions below the downstream sides of crossings to improve cover and spawning substrate
- Develop a fisheries component to the land management plan

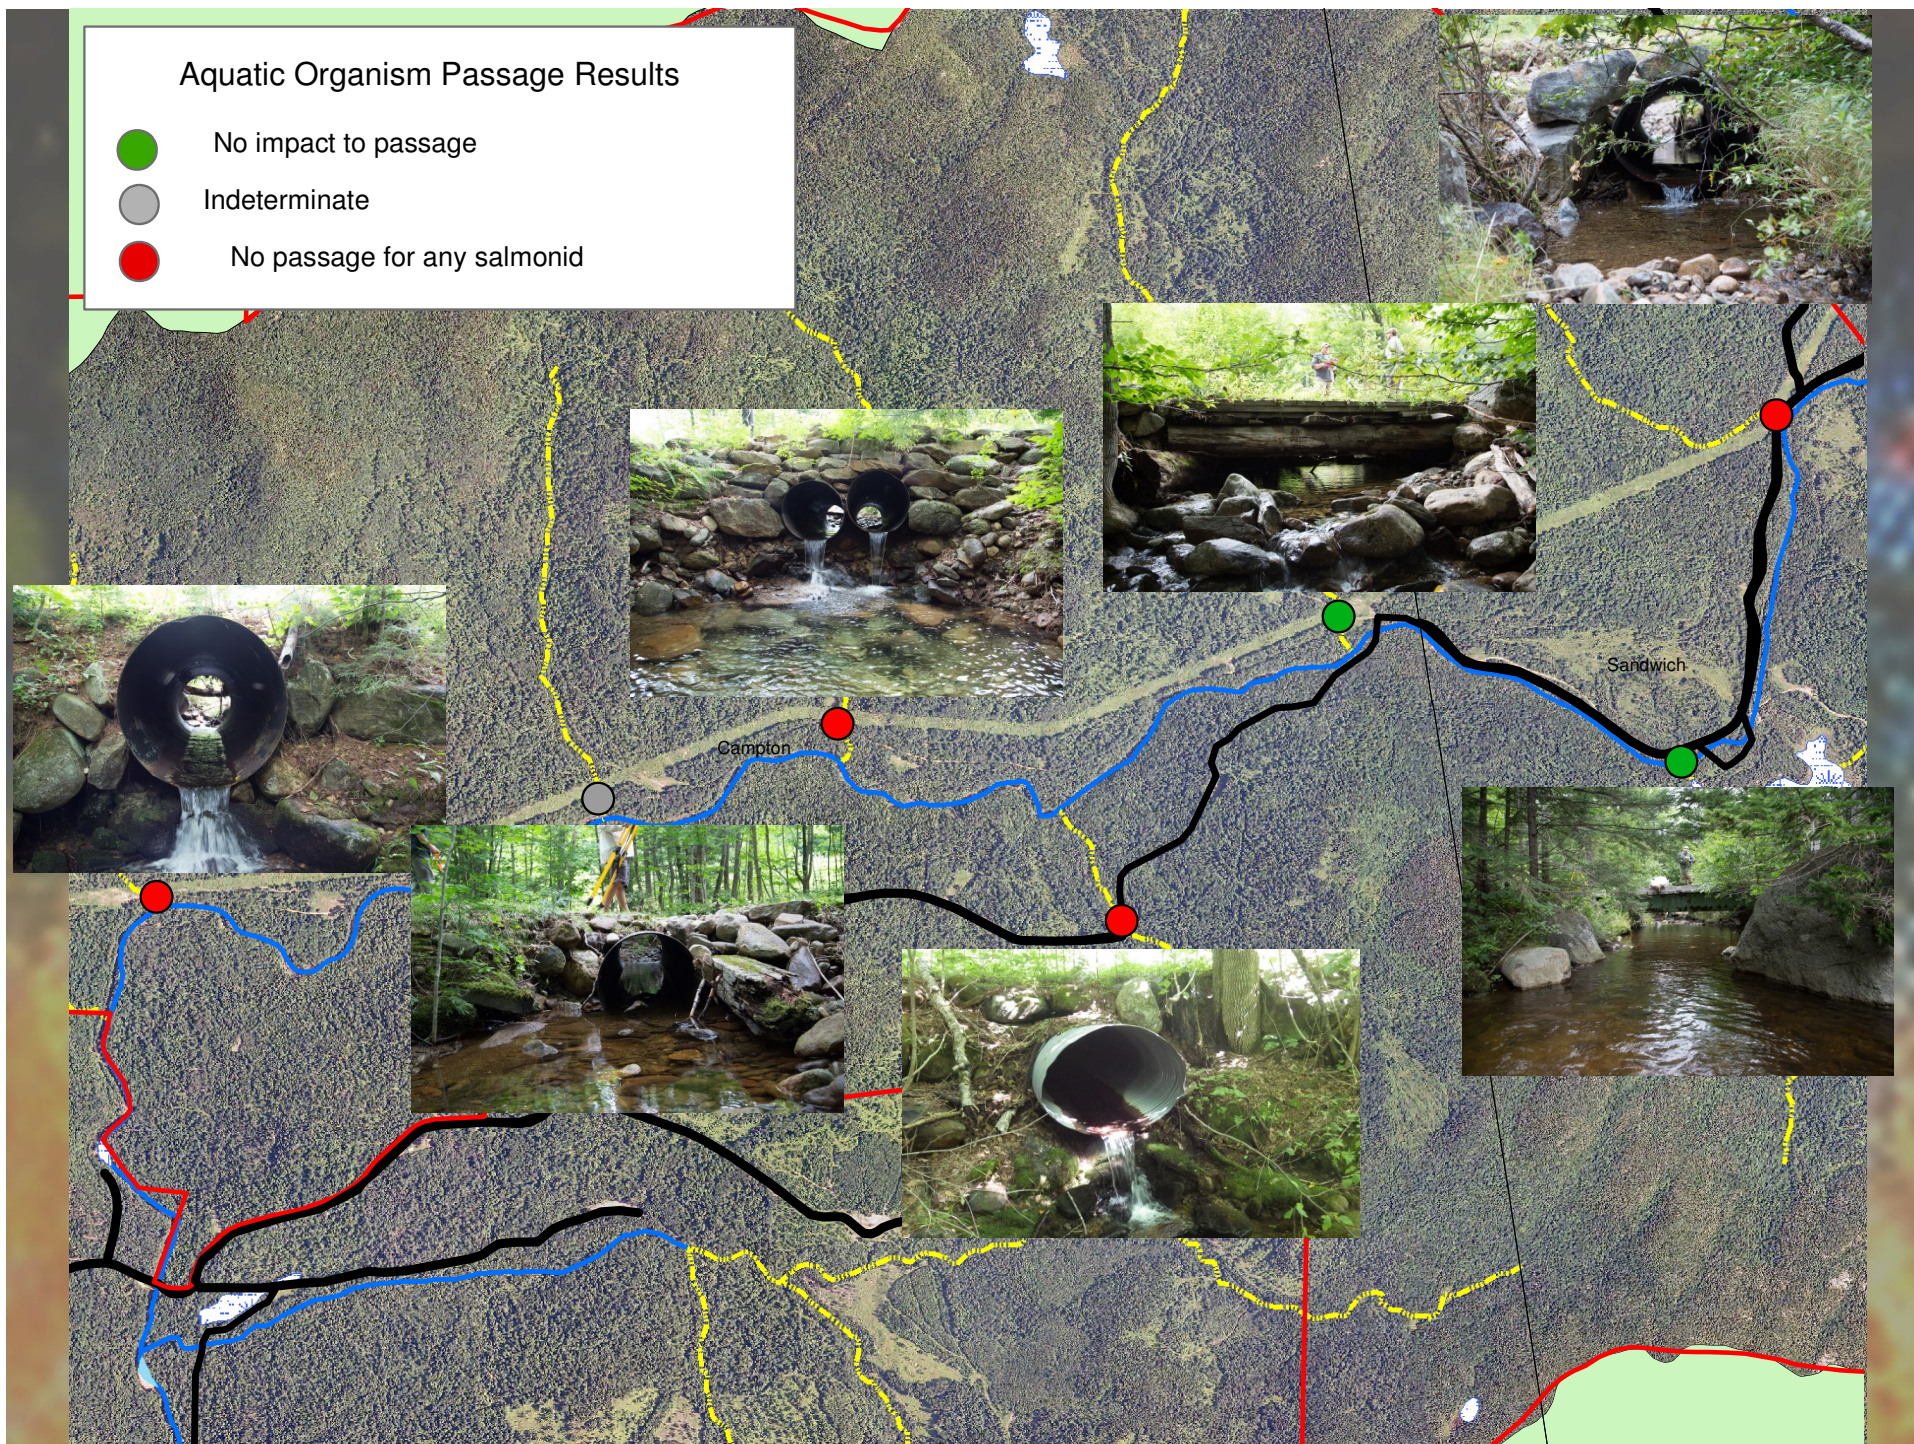
## Aquatic Organism Passage Results

No impact to passage

Indeterminate

No passage for any salmonid

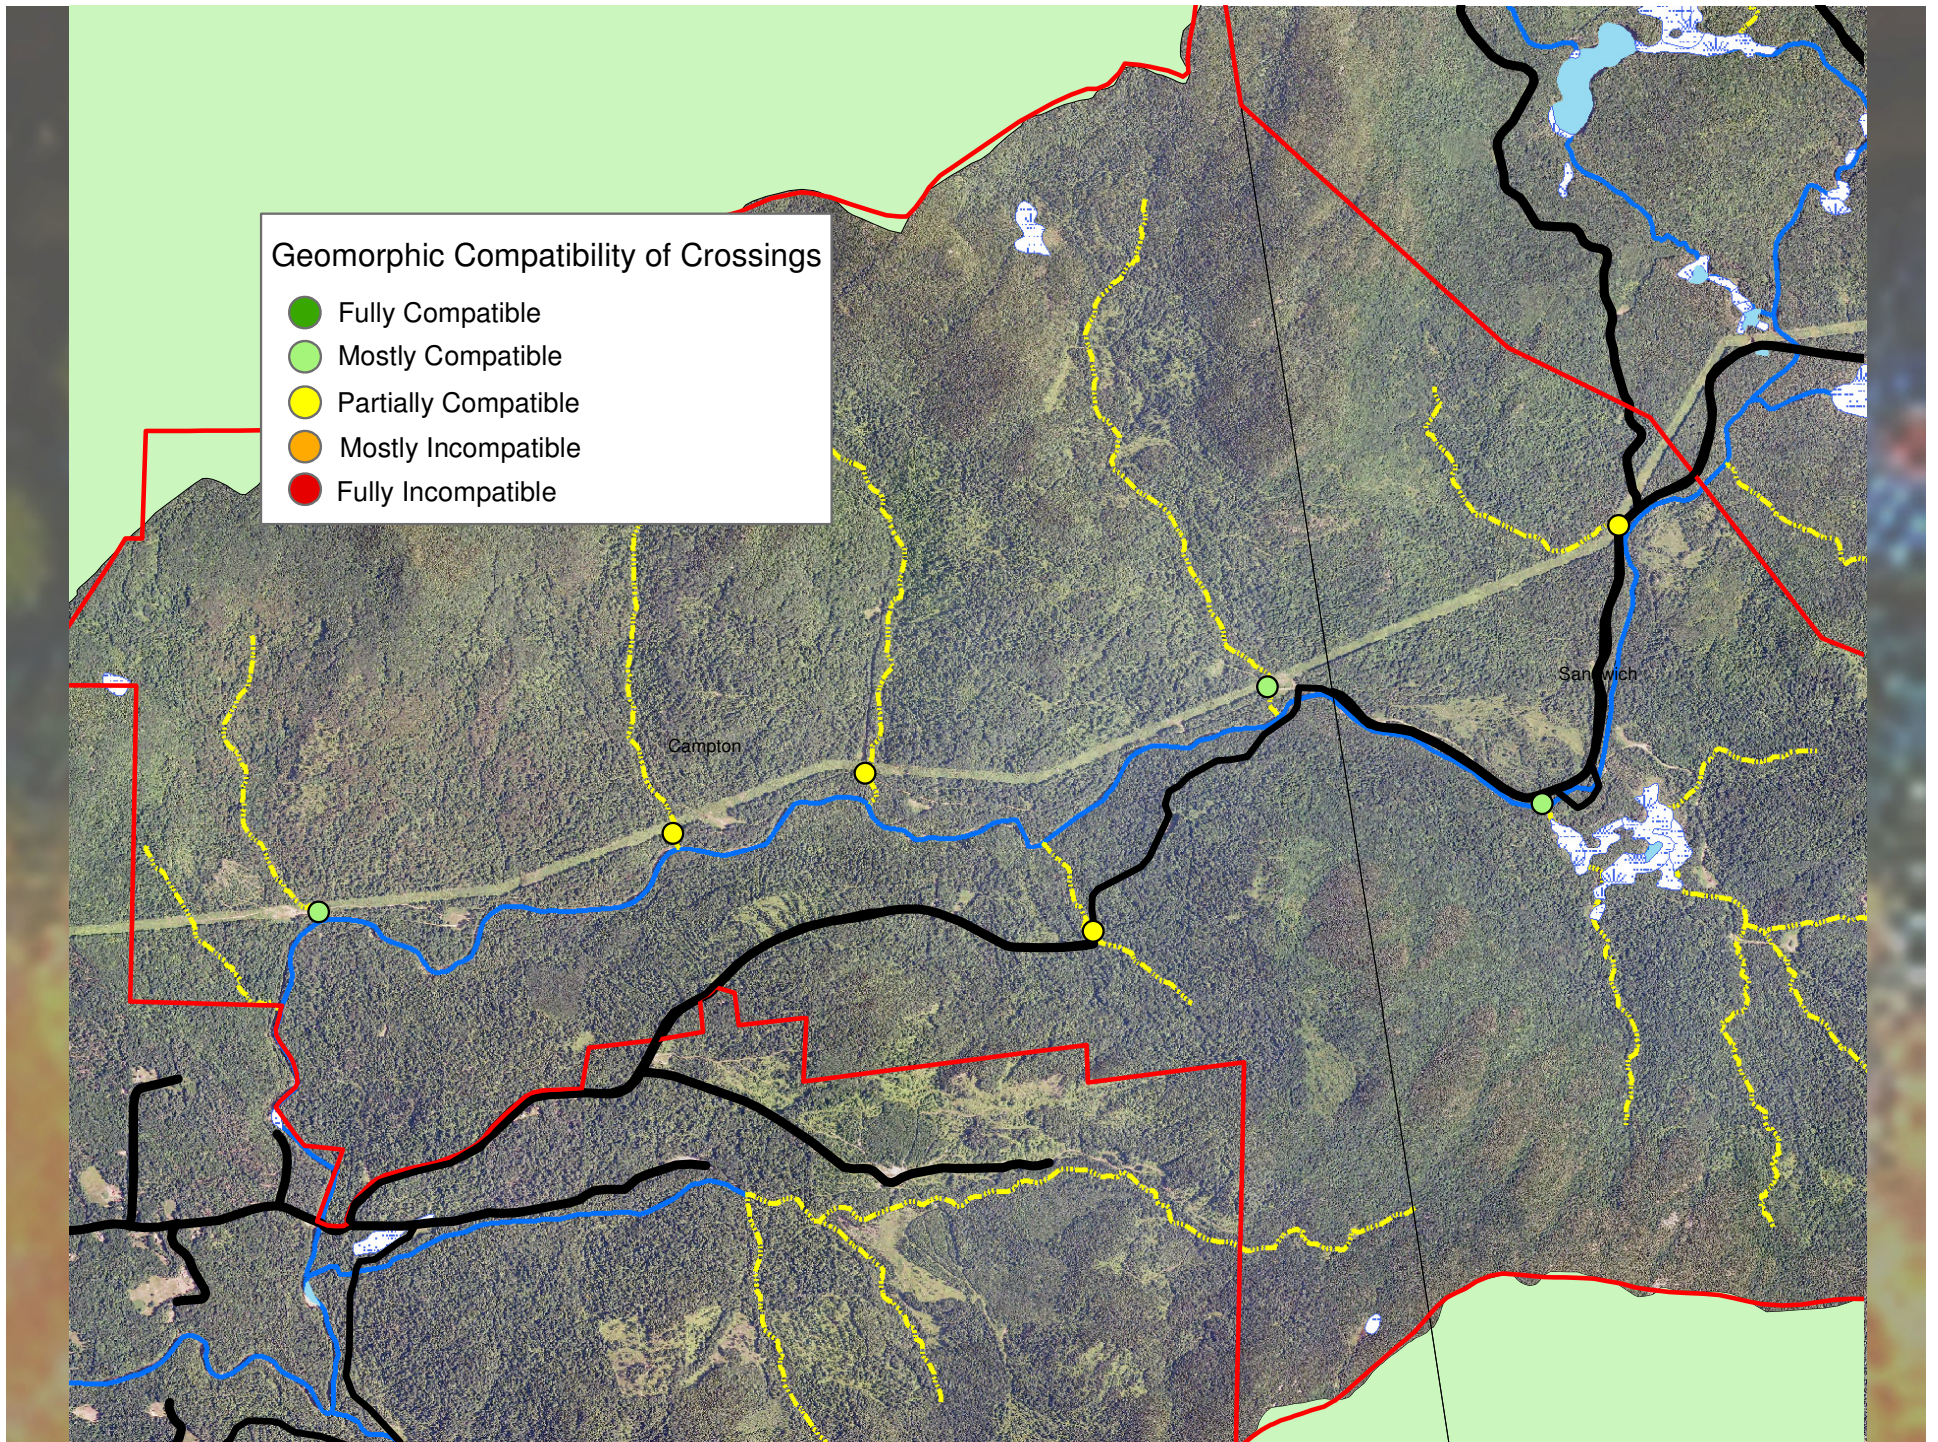
### Geomorphic Compatibility of Crossings

- Fully Compatible
- Mostly Compatible
- Partially Compatible
- Mostly Incompatible
- Fully Incompatible
