Bath, New Hampshire:

Brook Trout Report & Recommendations for Conservation

Undergraduate Thesis

*Emma Lundberg, Southern New Hampshire University
New Hampshire Fish & Game Department
June – 2012*

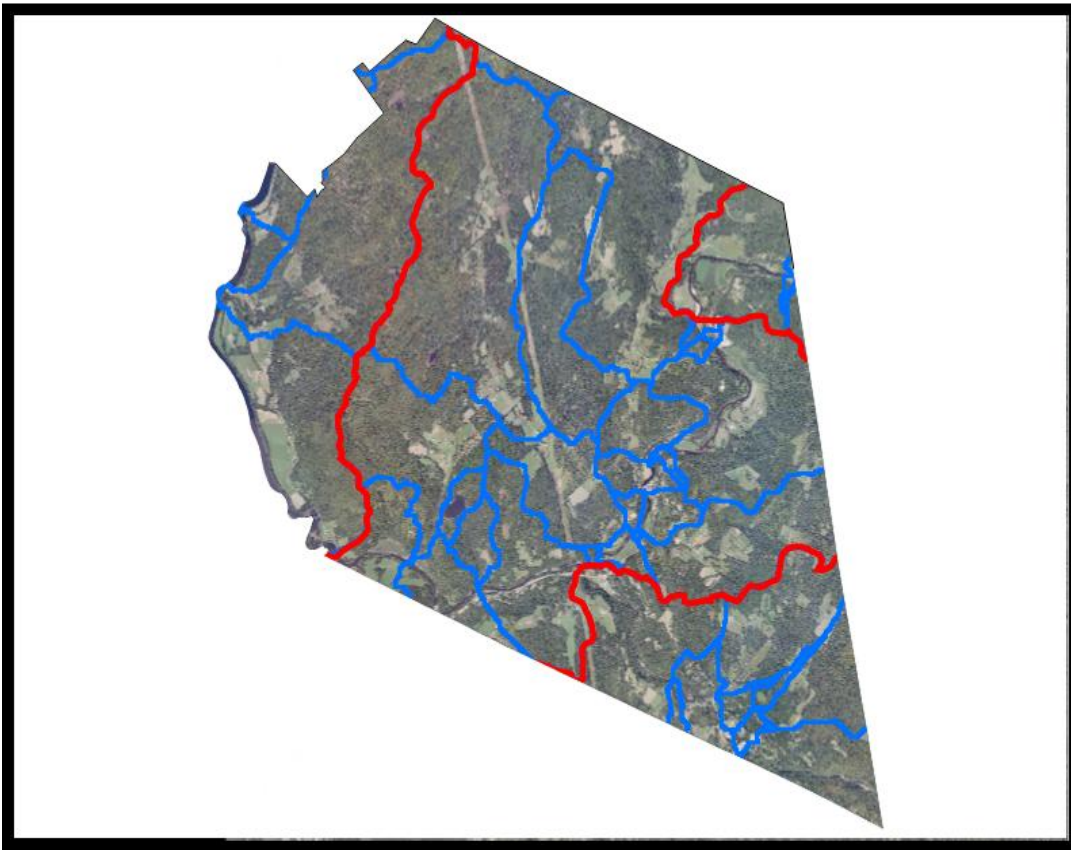
Figure 3. Subwatershed (red) and catchments (blue) boundaries within the town of Bath.

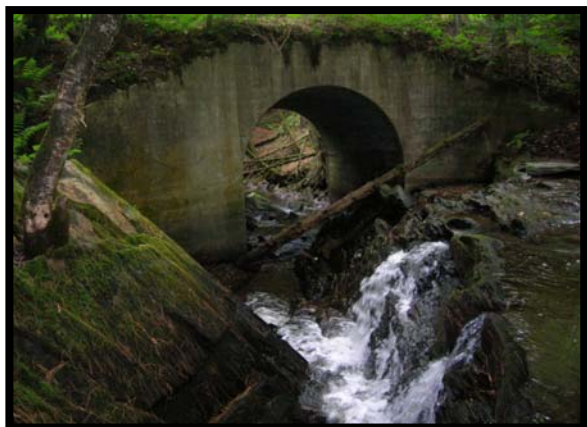
Figure 4. Improperly designed crossing on Lower Childs Brook, Bath, NH.

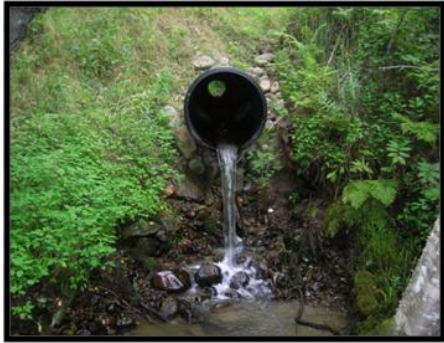
A culvert is considered perched when the downstream end is positioned above the streambed, thereby creating a waterfall upon release (Figures 7 and 8). A perched culvert can result from long periods of erosion caused by crossings that are undersized or improperly placed during installation. Perches can range from a few inches to a few feet and can impede fish and other organisms.

Figure 7. Unnamed Stream, Bath NH (site#14725).

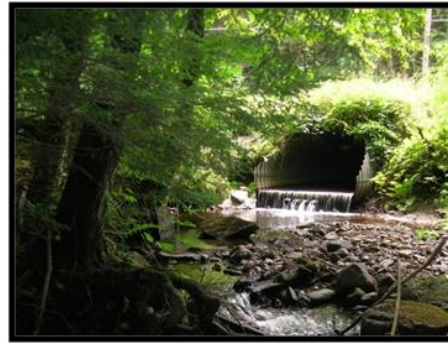
Figure 8. Waterman Brook, Bath, NH (site # 14571).

A large perched culvert exists on Goose Lane. The culvert is too narrow and caused bank and streambed erosion. In an effort to reinforce the deteriorating culvert, concrete was poured along its bottom for the entire length of the culvert and around each end. This has caused the flow of the stream to be at a minimal depth, prohibiting fish movement. Replacing the crossing with one that can handle a larger, more dynamic flow regime, such as an open bottom culvert or a small bridge, would reduce erosion and sedimentation at this location. This would also enable upstream and downstream migration during a variety of flows.

1. Replace culvert with appropriately designed stream crossing using the *New Hampshire Stream Crossing Guidelines* (2009).
2. Establish riparian buffer along stream by planting native trees and shrubs, where necessary that will stabilize the bank, provide shade to the stream and provide habitat for wildlife.

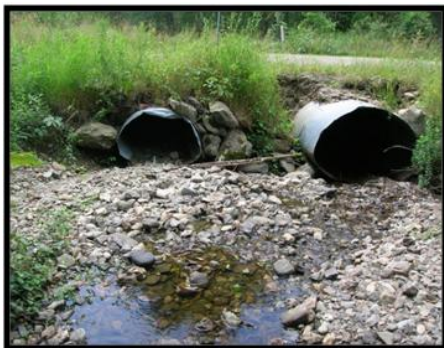
An undersized culvert is a stream crossing that is too small to accommodate the variability in natural flow or the movement of sediment within a stream. Undersized crossings can increase stream flow, which cause sediment deposition (aggradation) at the upstream side of the crossing and scouring downstream of the crossing (Figures 9 and 10). They typically require frequent maintenance due to clogging, erosion and washouts likely to occur during high flow events. Erosion at stream crossing locations can alter stream habitat around both the inlet and outlet of a crossing, as well as areas downstream.

Figure 9. Upper portion of Childs Brook, Bath, NH (site # 14700).

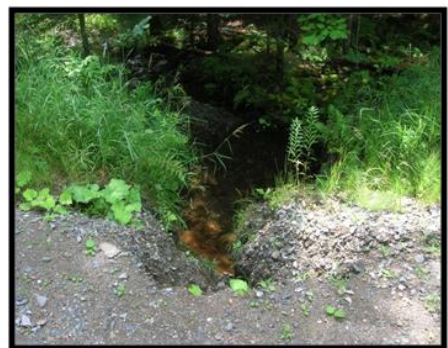
Figure 10. Washout at Unnamed Stream, Bath, NH (site # 14699).

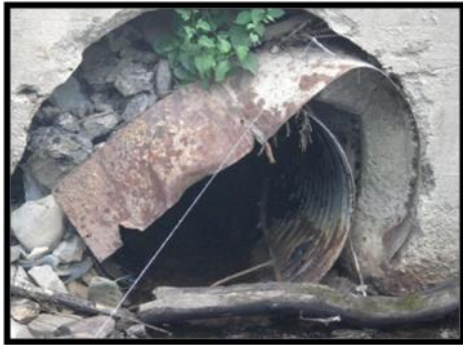
Figure 11. Slip lined crossing on unnamed tributary, Bath, NH.

inserting a lining into the compromised pipe (Figure 11).

Although inexpensive, this method is not highly recommended. It further constricts stream flow by reducing the area within the culvert where the water needs to pass through. This reduction increases stream velocity leading to further scouring and erosion of the streambanks downstream. It is particularly problematic to implement a slip liner into an already undersized culvert. Slip lining

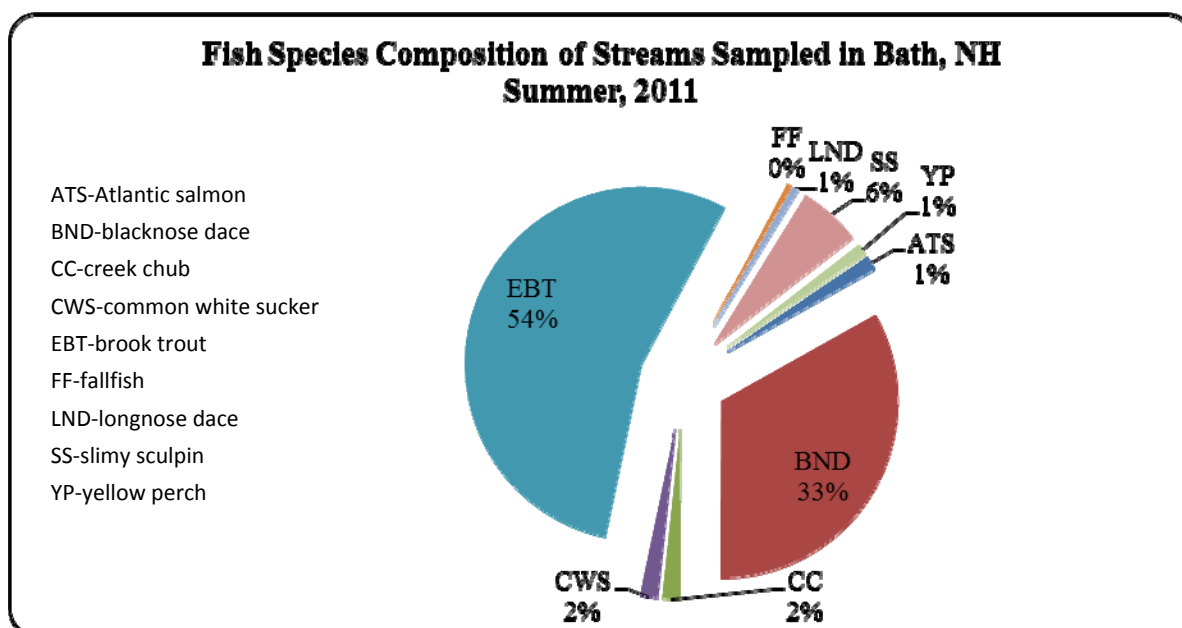
A variety of fish species were observed, with brook trout being the most abundant (Figure 12).

Figure 12. Fish species observed during sampling in Bath, NH (2011).
